NSWCCD-65-TR-2003/39 September 2003

SIDER Testing of Two Range Safety Craft

SUBJ: STRUCTURAL IRREGULARITY AND DAMAGE EVALUATION ROUTINE
(SIDER) INSPECTION OF SHIP STRUCTURES

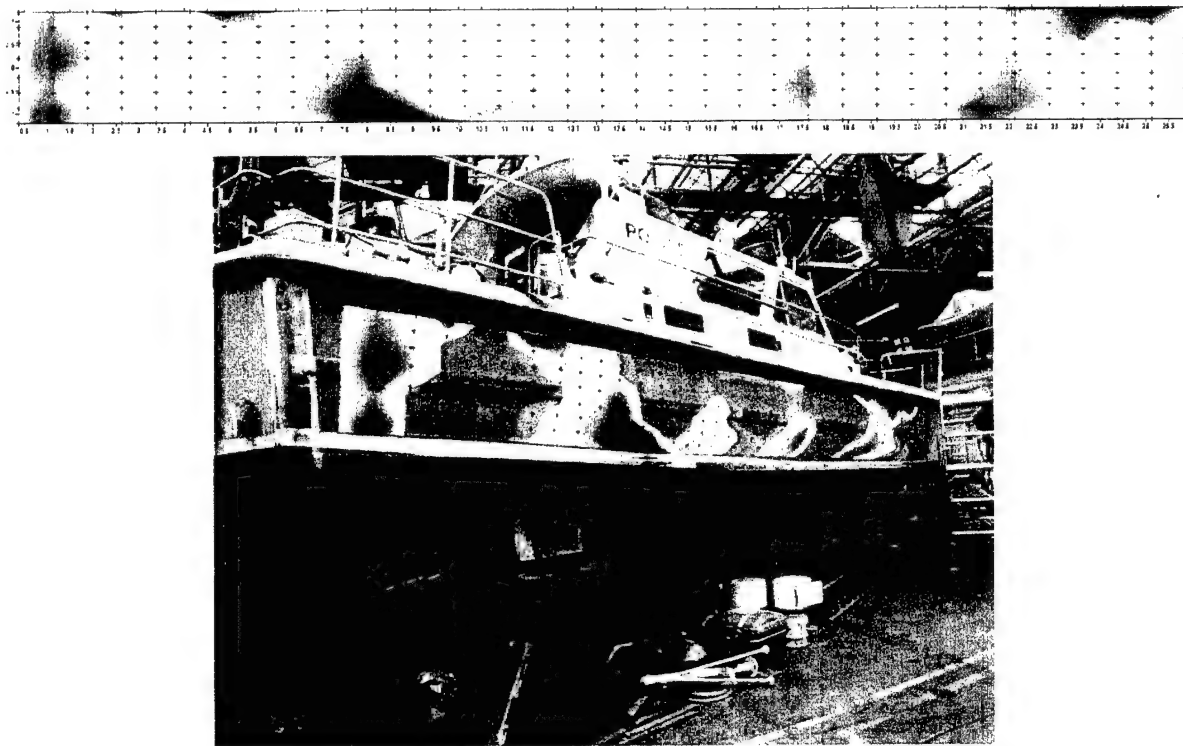
Figure 9. SIDER Results for Test ID R1

The two results show a remarkable agreement in both pattern of features and magnitude of SIDER values. Both tests identify the same basic regions as "clear" of irregularity. The main difference seems to be that the features identified by the small hammer are slightly larger in both magnitude and area.

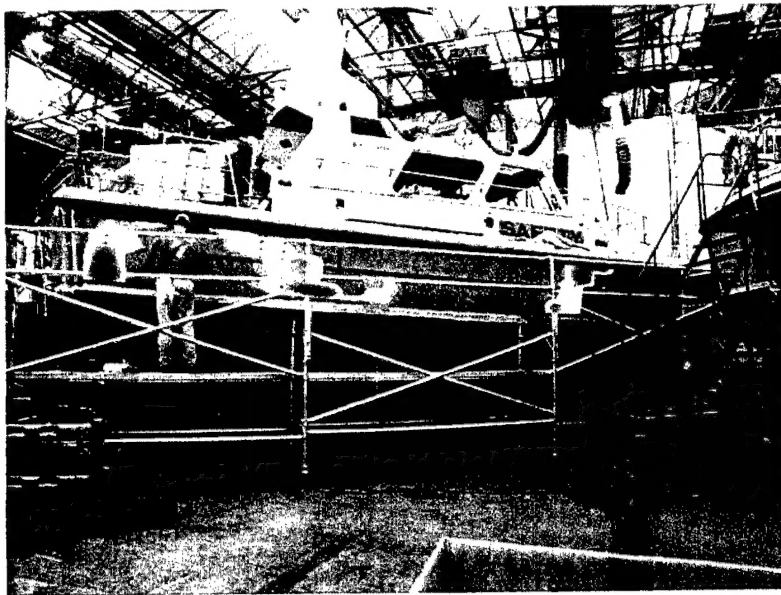
Figure 11. SIDER Results for Test ID R3

The two RSCs are sister vessels. There are, though, some differences. RSC Police had its starboard engine installed, whereas RSC 8126 had no engines in place. Also, there were some differences in internal attachments to the hull, and the hull penetration layouts were different. Despite these differences, the SIDER inspections have produced very similar plots of structural irregularity features. This result suggests that a baseline SIDER from one vessel may be useful in identifying problems with another hull.

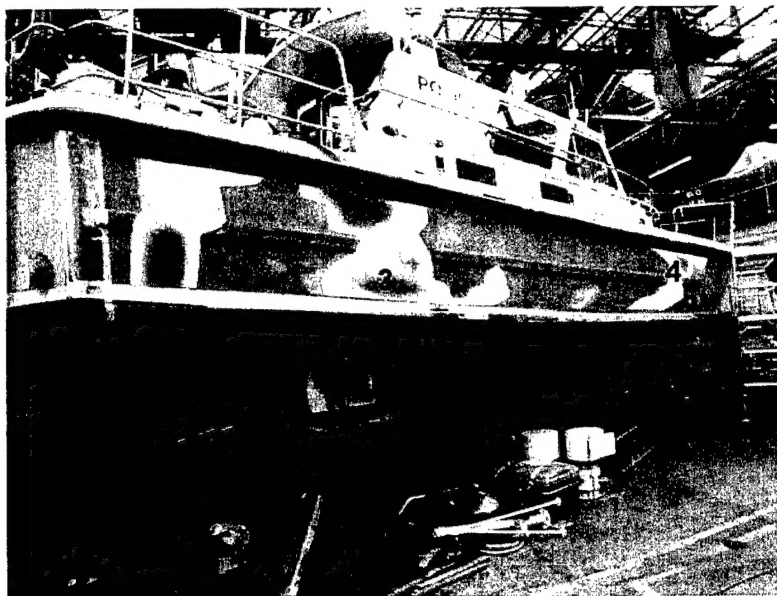
Figure 12. SIDER Results for Test ID R2 with Marked Features

Feature 1 is coincident with an internal bulkhead. Examination of this part of the RSC Police hull by Keith Vernon, Senior Surveyor, Lloyd's Registry of London, confirmed that this SIDER feature had identified damage (probably delamination or debonding) between the main hull shell and the bulkhead. This is a high-risk part of the vessel, since it often gets hit during alongside maneuvers. There was also some nearby cracking of the internal bulkhead, but this

was not in the area that had been SIDER inspected. Mr. Vernon did note, though, that the identification of this crack was significantly aided by knowledge of the damage location identified by the SIDER analysis.

Feature 2 is strong on RSC Police, but minimal on RSC 8126. Internally to RSC Police, there is a wiring support harness at this location. It does not exist in the RSC 8126. It is speculated that SIDER has located the wiring harness, but it is possible that there is other hidden structural irregularity. The wiring harness is shown in Figure 13.

Feature 3 shows on the results for both craft. There were no obvious problems or structural features at this location, but since the feature is apparent on both RSC results, it presumably maps to some structural or damage-related stiffness variation. The thick noise and vibration lagging on the inside surface of the hull precluded a detailed investigation of this area.

Feature 4 also shows on the results for both craft. At this point inside the hull there is a small galley, and it was not possible to get to the inside surface of the hull shell. However, this is another high-risk part of the hull, prone to impact damage during alongside evolutions.
